NO CLEAN-UP, **NO JUSTICE**

**AN EVALUATION OF THE IMPLEMENTATION OF UNEP'S
ENVIRONMENTAL ASSESSMENT OF Ogoniland, NINE YEARS ON**

JUNE 2020

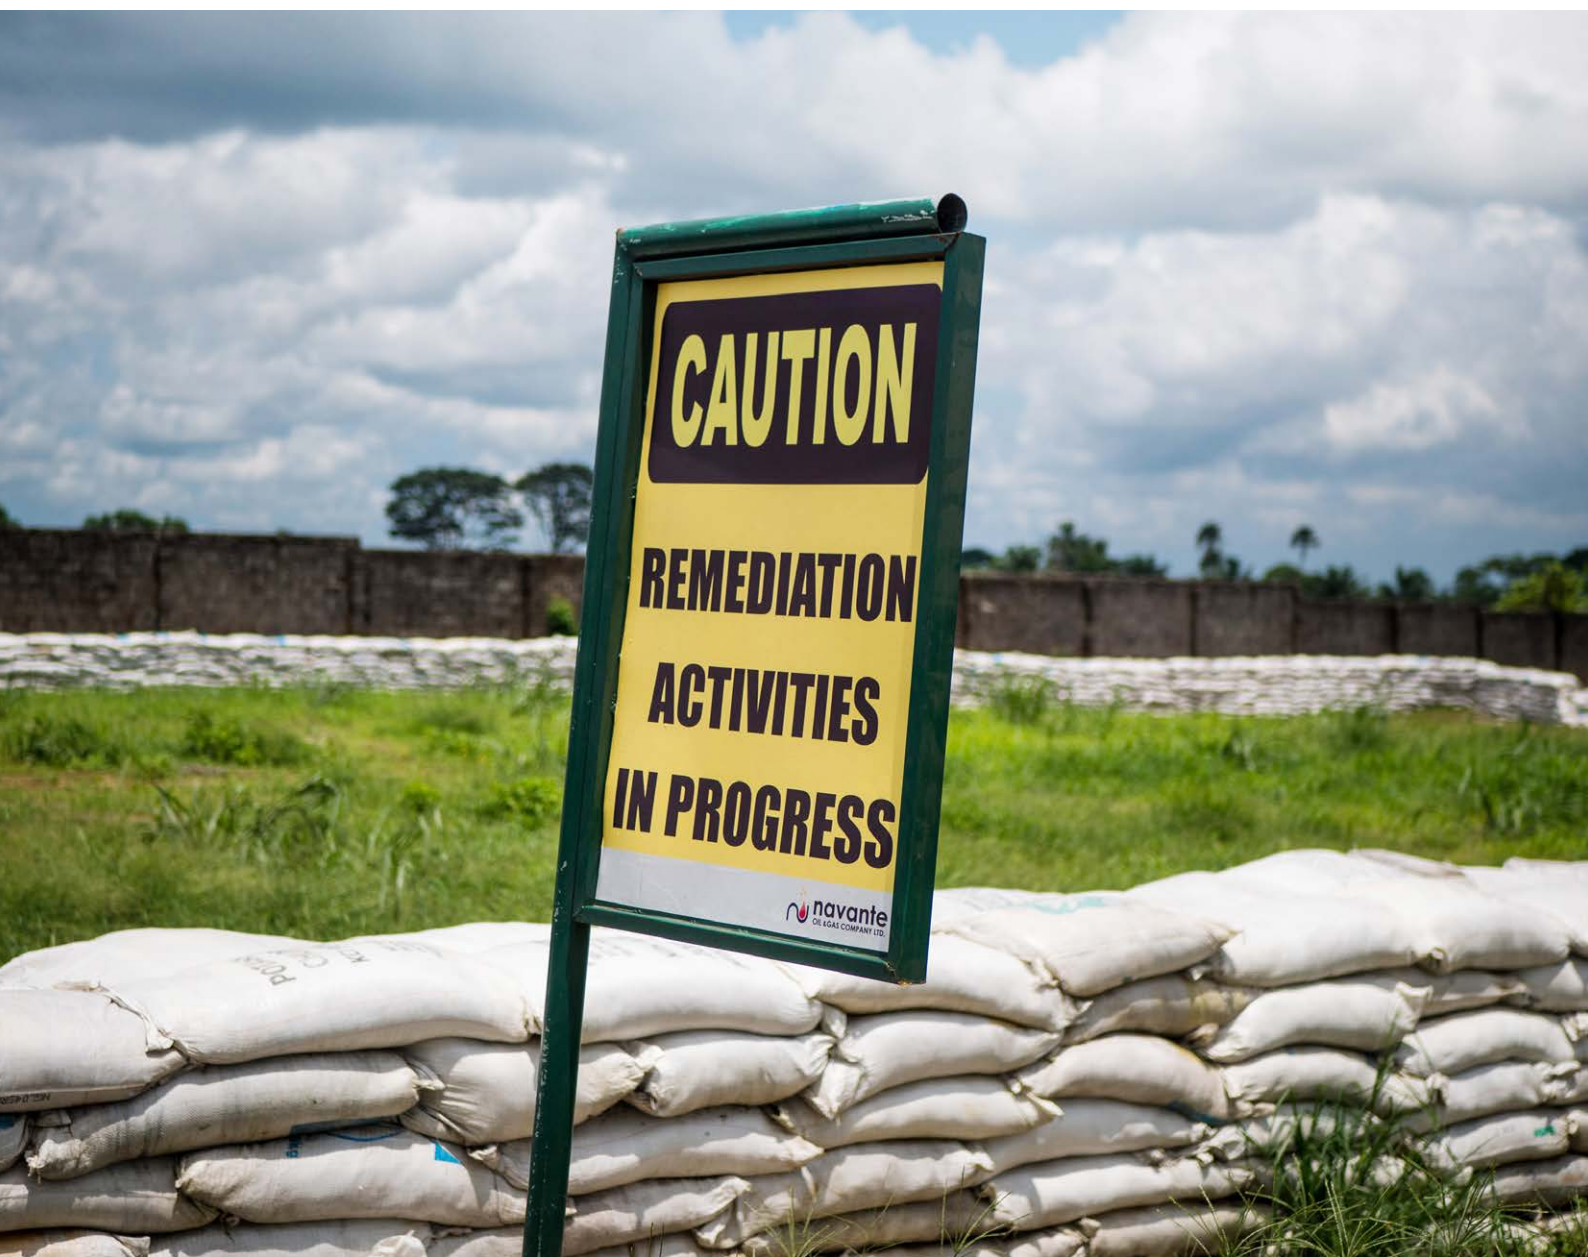
Cover photo: Lot 14: There is no activity on this lot, just some bags of white sharp sand gathered. © Isaac Harry/cmapping.net Date: April 2020

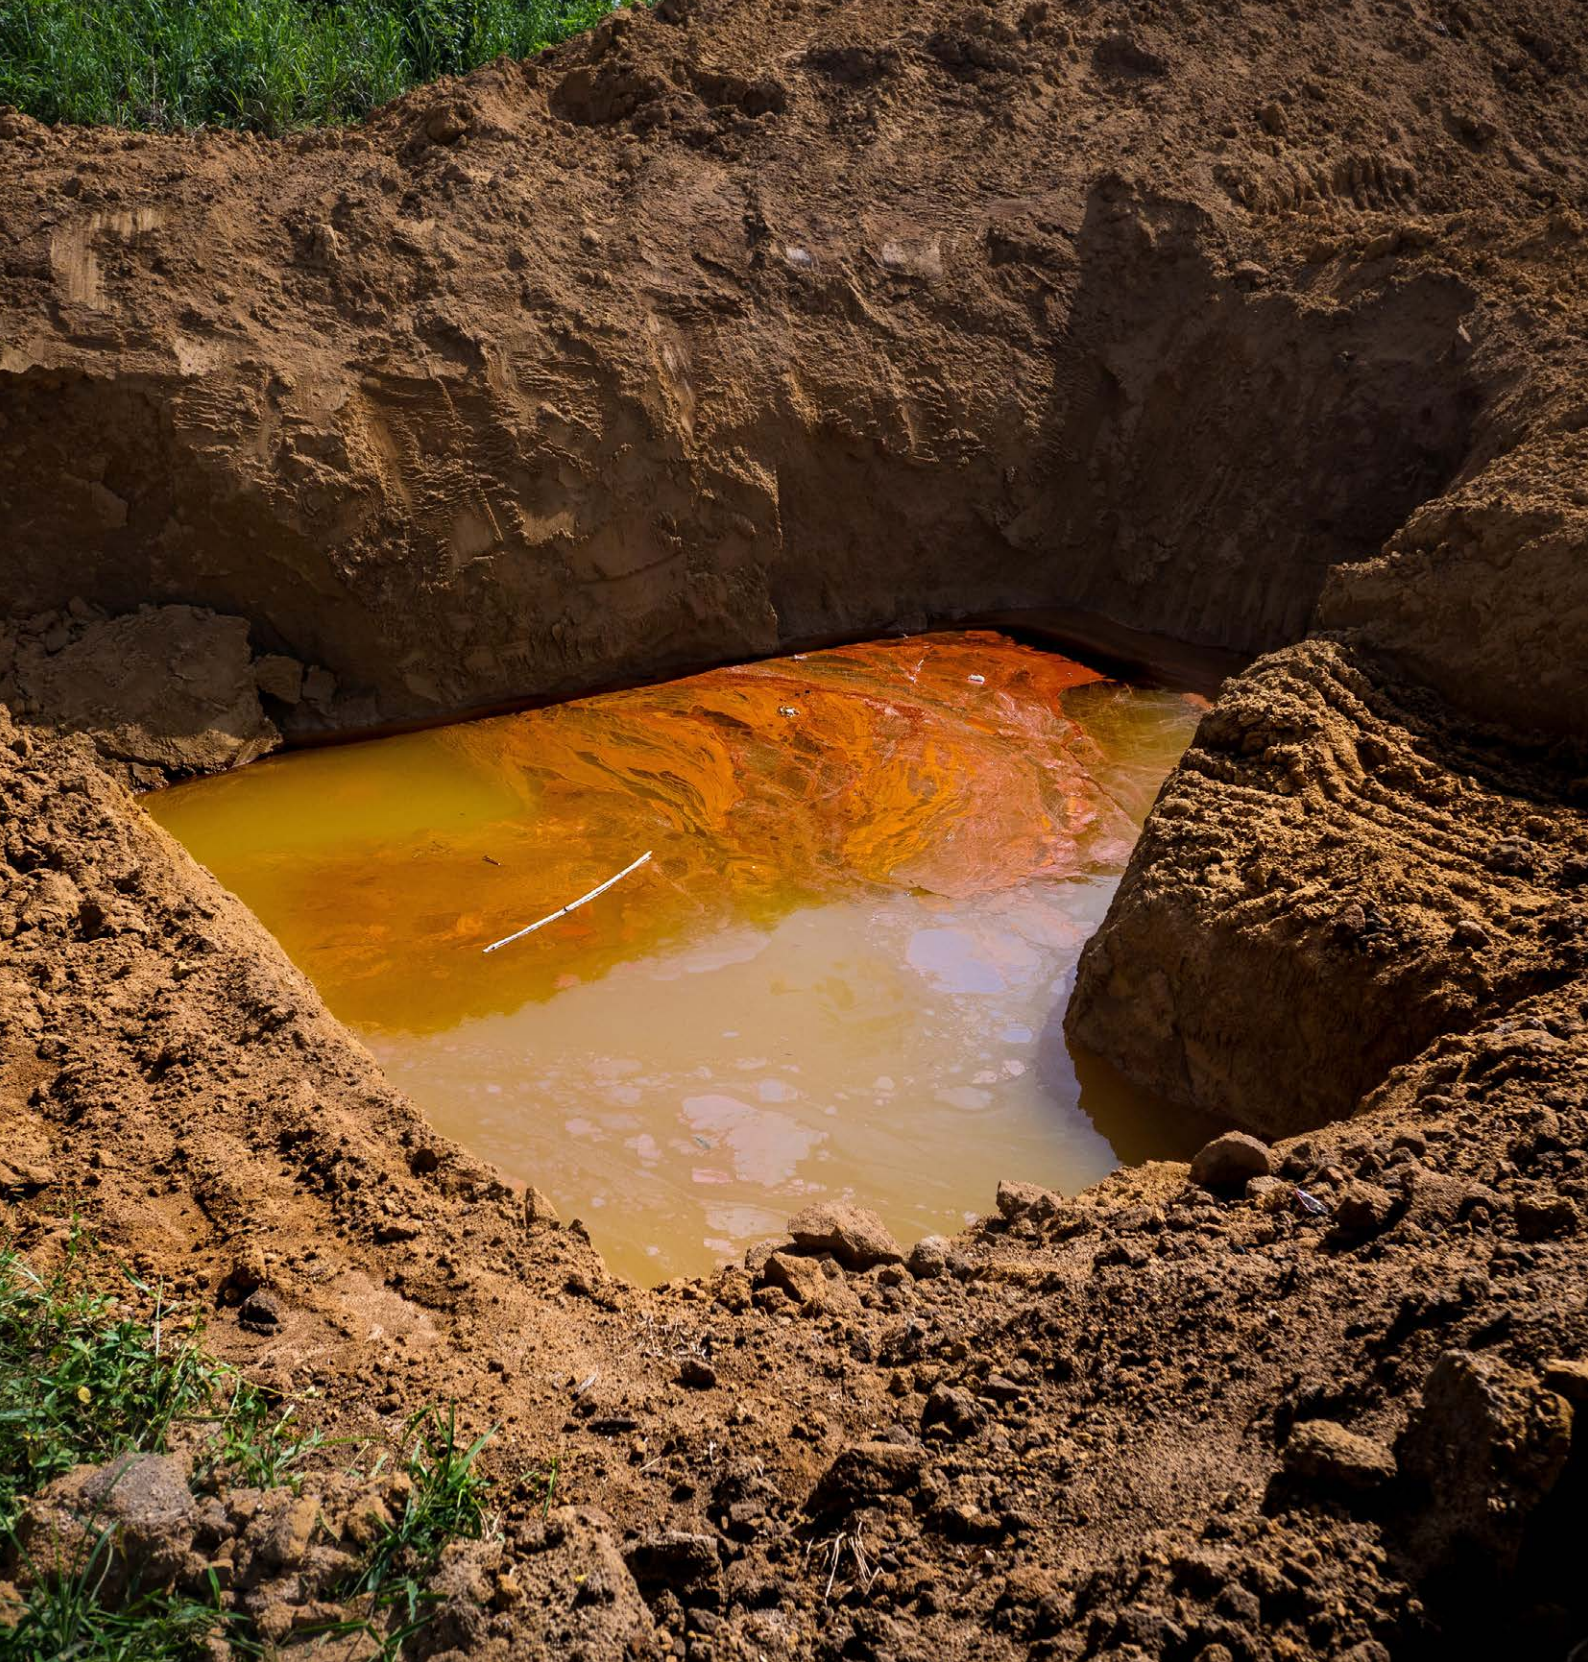
Lot 10: The excavated trench, with patches of oil and oxidized iron on groundwater. © Isaac Harry/cmapping.net Date: April 2020

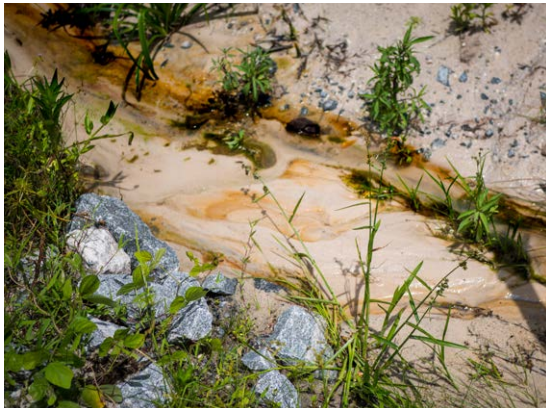
Lot 9: Contamination from this lot still appears to be spreading into the surrounding environment. A stream that is still polluted, judging by its visible oil sheen, is flowing from Lot 9 towards other clean up lots and the Patrick water-front in Bodo community. © Isaac Harry/cmapping.net Date: April 2020

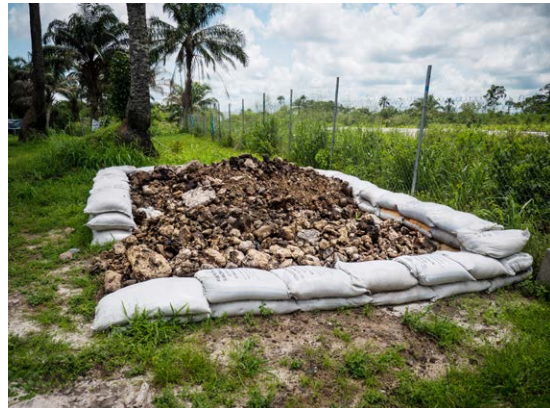
Lot 10: Carbonated materials from the site were placed in the open, on the ground without utilizing impermeable HDP material to prevent leaching of these materials back into the soil. © Isaac Harry/cmapping.net Date: April 2020

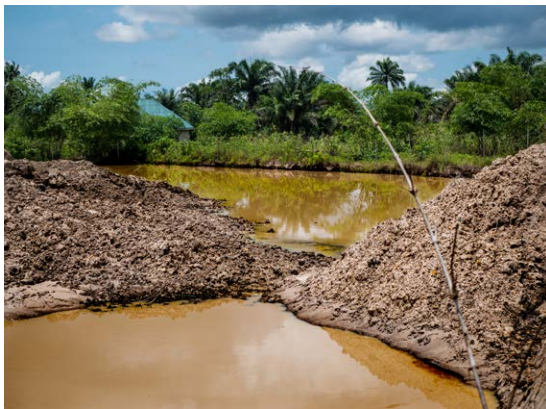
Lot 10: Oil is visible on the surface of the water in the excavated area. © Isaac Harry/cmapping.net Date: April 2020

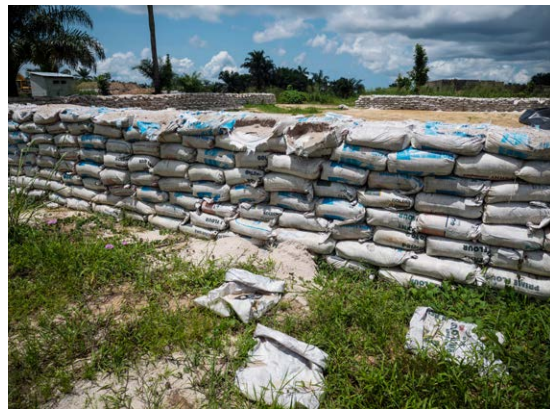
Lot 11: The bio cell has been partially constructed but the sand bags used for the bund wall are already torn, compromising its structural integrity. © Isaac Harry/cmapping.net Date: April 2020

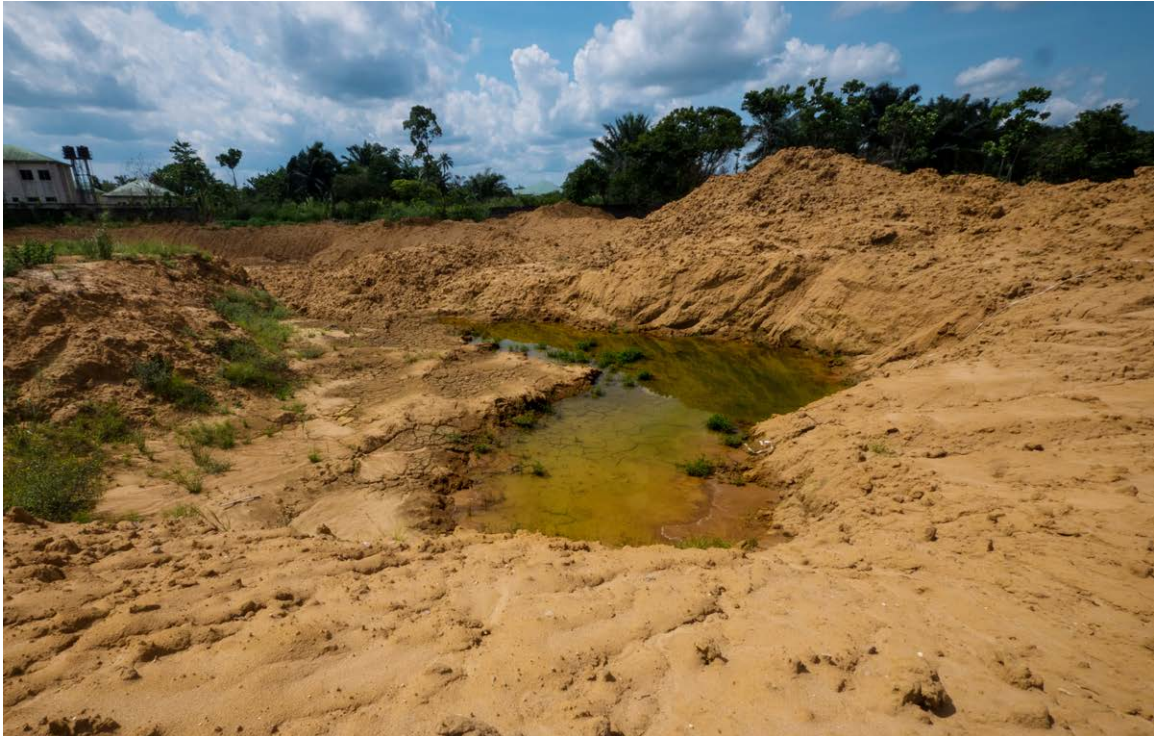
Lot 19: Untreated contaminated soil excavated in December 2019 is still in the open and placed side by side with treated soil. Since the excavated area isn't secured or properly separated, contaminated soil is washing into the treated soils around the area and those that have been backfilled in the trenches when it rains. © Isaac Harry/cmapping.net Date: April 2020

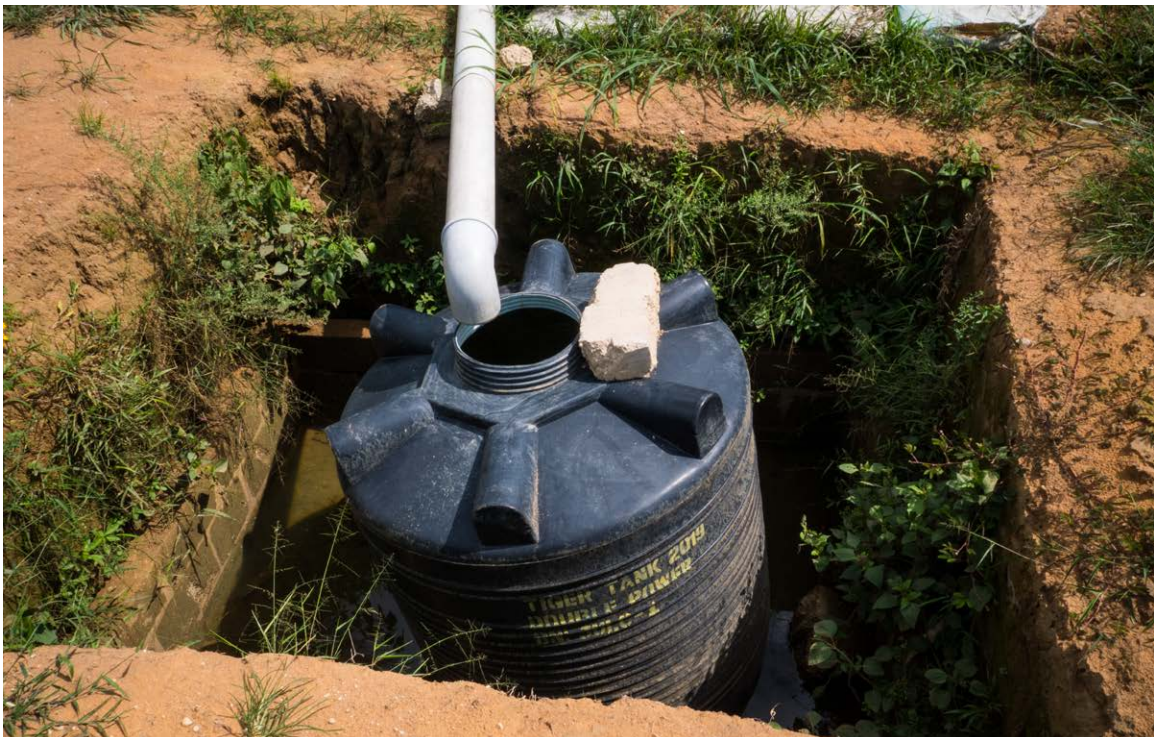
Lot 20: Poorly constructed sump. The sump isn't covered so when it rains the sump fills up and spills into the surrounding environment. © Isaac Harry/cmapping.net Date: April 2020
